1. INTRODUCTION

This connector is supplied to the customer with the Terminal Position Assurance (TPA) in the pre-assembled (pre-set) position. See Figure 1, Detail A.

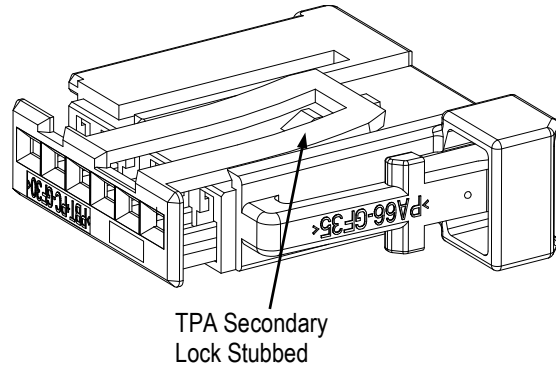
Detail B

Improper engagement of the TPA can cause stubbing. See Figure 1, Detail B.

Stubbing will prevent fully locking of TPA and prevent proper contact insertion. This can be avoided by correct engagement of the TPA. Follow the procedures given in Section 2, ENGAGEMENT PROCEDURE.

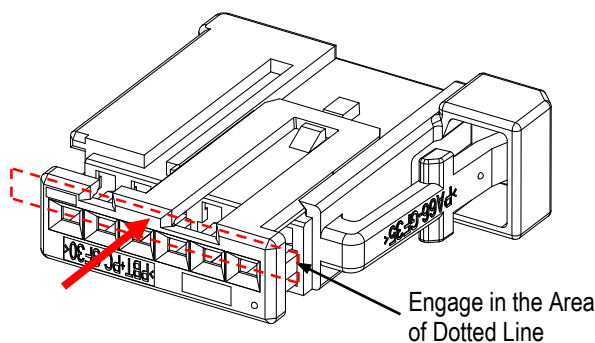
Figure 2

Top (TPA Latch) Side

1. With the TPA at the pre-set position, engage the TPA from the top (latch side). See Figure 2.
2. Do not engage TPA from the bottom side. See Figure 3.

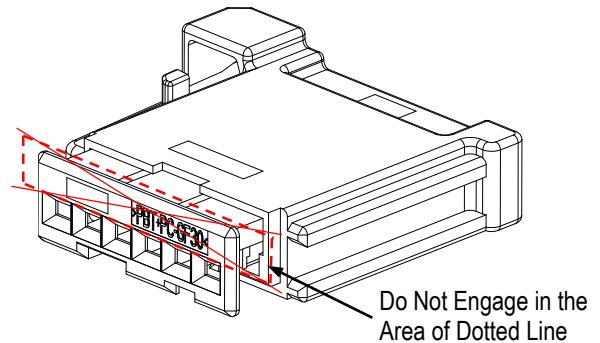
Figure 3

Bottom (TPA Finger) Side
