# Test Report

## Industrial M12 Series Circular Connector

Tyco Electronics. (Shanghai) Co., Ltd.

Testing was performed on Industrial M8 and M12 Series Circular Connector to determine its conformance to the requirements to product specification 108-106140.

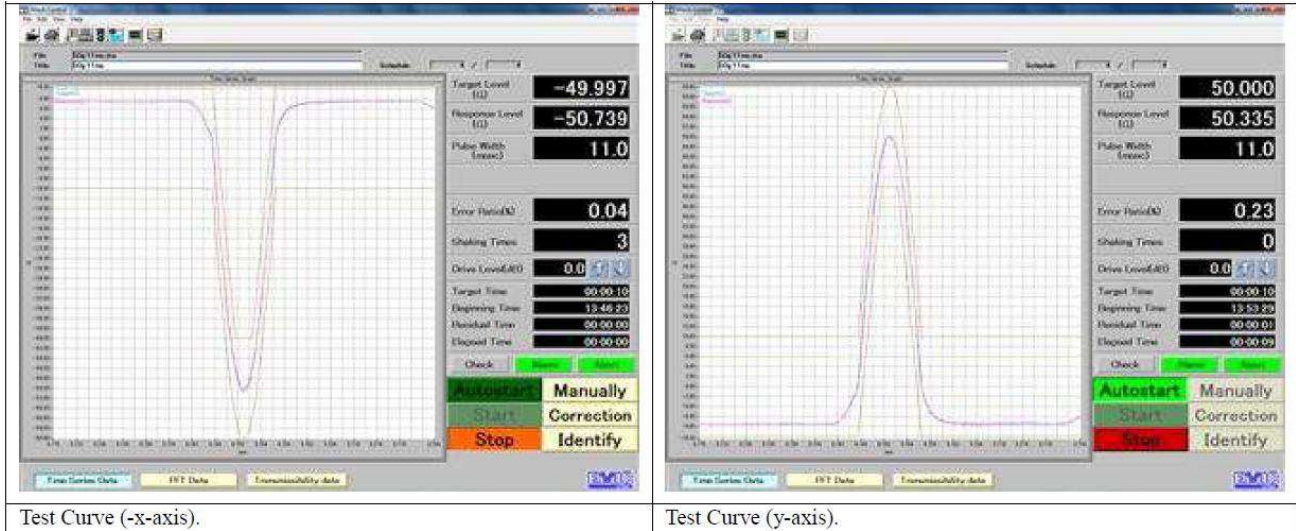
Fig.4

2.3.2 Mechanical shock

Text Curve(z-axis)

Test Curve (-x-axis).

Test Curve (y-axis).

Group	Test Item	Sample Number	Requirement	Result			Conclusion
				Max.	Min.	Ave.	
B	Vibration	3	No physical damage; No electrical discontinuity greater than 1 μs	Refer to fig.1, fig.2			meet spec.
	LLCR	3	Δ15 mΩ Max.	6.46	1.37	2.77	meet spec.
	Mechanical shock	3	No physical damage; No electrical discontinuity greater than 1 μs	Refer to fig.3, fig.4			meet spec.
	LLCR	3	Δ15 mΩ Max.	10.87	4.29	7.89	meet spec.
	Rapid change of temperature	3	No visual change	Refer to Fig.5			meet spec.
	LLCR	3	Δ15 mΩ Max.	4.16	1.89	2.46	meet spec.
	Insulation resistance	3	100MΩ Min	6.66x10 <sup>10</sup> Ω	3.58x10 <sup>10</sup> Ω	5.11x10 <sup>10</sup> Ω	meet spec.
	Voltage Proof	3	No breakdown or flashover	No breakdown and flashover			meet spec.
	Dry Heat	3	No visual change	No visual change was found after test. Fig.6			meet spec.
	Insulation resistance	3	100MΩ Min	7.51x10 <sup>10</sup> Ω	1.2x10 <sup>10</sup> Ω	4.27x10 <sup>10</sup> Ω	meet spec.

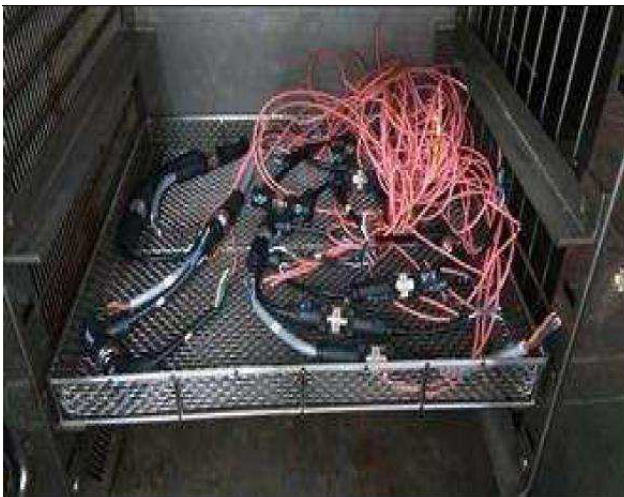
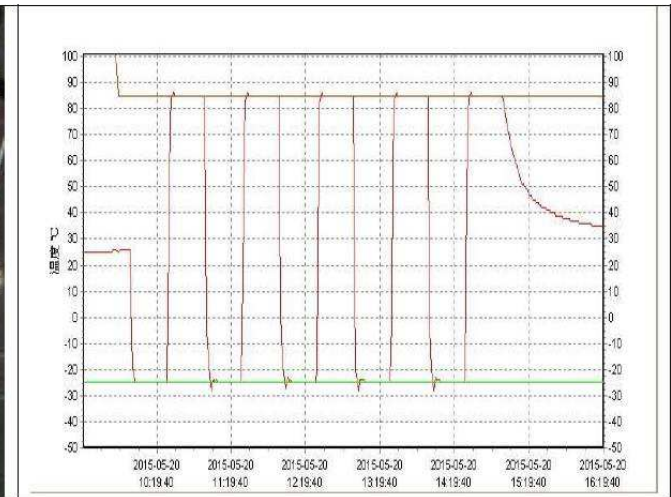
2.3.3 Rapid Change In Temperature

Group	Test Item	Sample Number	Requirement	Result			Conclusion
				Max.	Min.	Ave.	
D	Rapid change of temperature	3	No visual change	Refer to Fig.5			meet spec.
	LLCR	3	$\Delta 15 \text{ m}\Omega$ Max.	8.00	3.21	4.06	meet spec.
	Insulation resistance	3	100M $\Omega$ Min.	$2.9 \times 10^{10} \Omega$	$5.46 \times 10^9 \Omega$	$1.16 \times 10^{10} \Omega$	meet spec.
	Voltage Proof	3	No breakdown or flashover	No breakdown and flashover			meet spec.
	Temperature rising	3	$\Delta T 30^\circ\text{C}$ Max	Refer to Fig.12			meet spec.

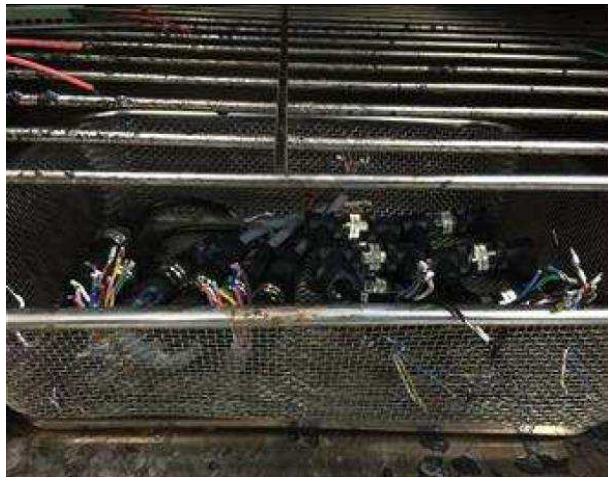
Fig.6

2.3.4 Dry Heat

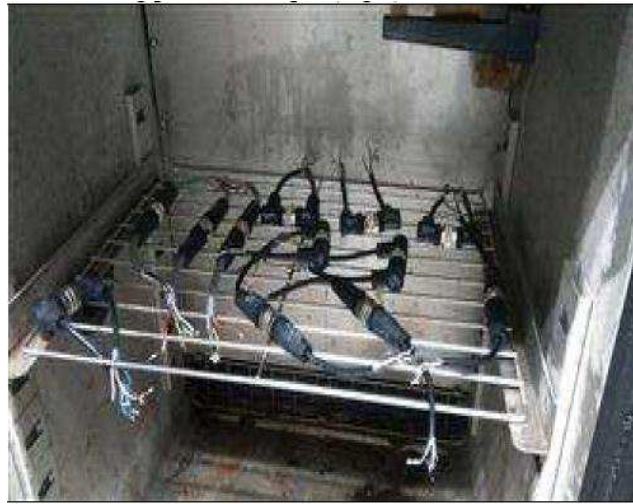
2.3.5 Damp Heat Cyclic

Damp heat, cyclic	3	No visual change	Refer to Fig.7			meet spec.
	Cold	3	No visual change	Refer to Fig.8			meet spec.
	Damp heat, cyclic	3	No visual change	Refer to Fig.9			meet spec.
	LLCR	3	Δ15 mΩ Max.	5.48	3.02	3.02	meet spec.
	Insulation resistance	3	100MΩ Min	11.97x10 <sup>10</sup> Ω	5.01x10 <sup>10</sup> Ω	8.04x10 <sup>10</sup> Ω	meet spec.
	Voltage Proof	3	No breakdown or flashover	No breakdown and flashover			meet spec.
Impacting water	3	No water ingress was found after test.	Refer to Fig.10			meet spec.

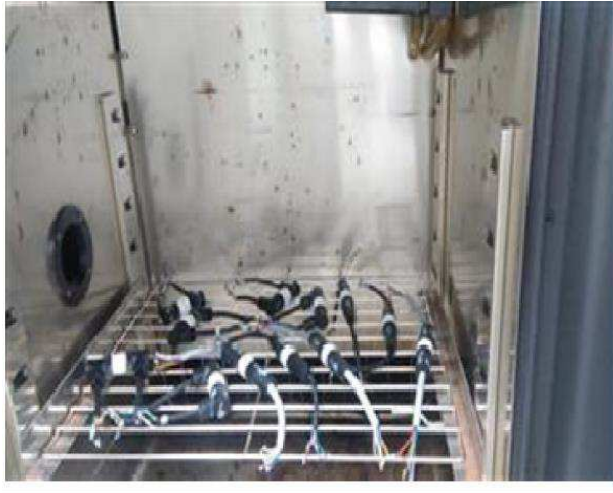
Fig.8

2.3.6 Cold

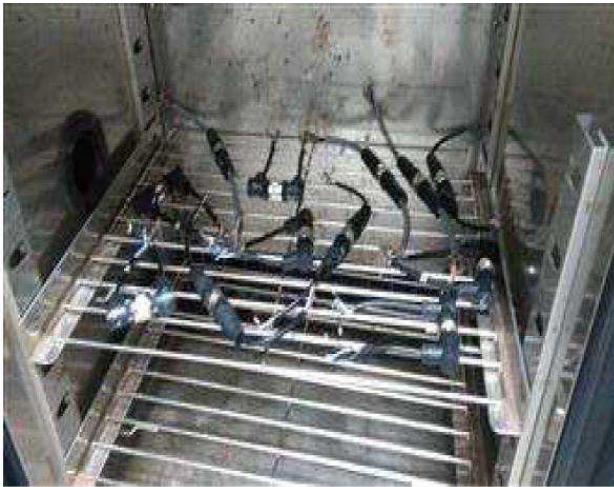
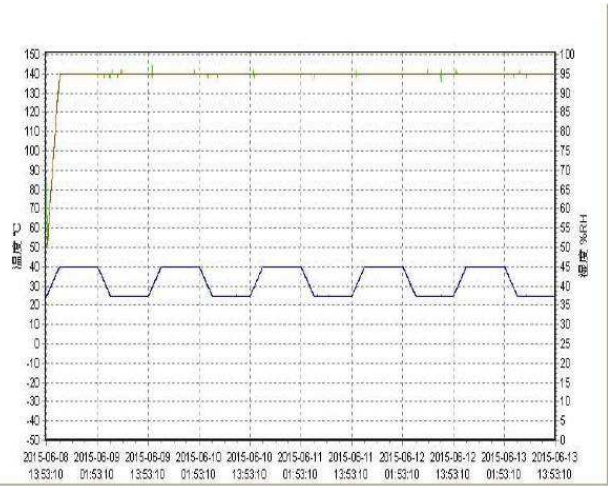
Fig.9

2.3.7 Damp heat, cyclic

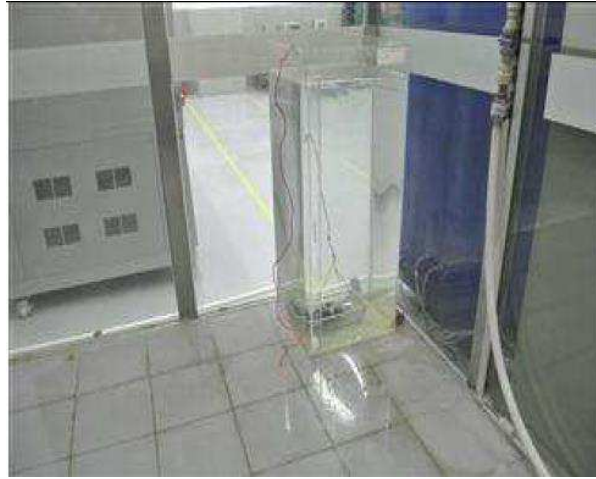
2.3.8 Impacting water

17.28 $^\circ\text{C}$	11.78 $^\circ\text{C}$	14.78 $^\circ\text{C}$	
	Impacting water	3	No water ingress was found after test.	Refer to Fig.10			meet spec.
	Insulation resistance		100M $\Omega$ Min.	$7.85 \times 10^{10} \Omega$	$1.32 \times 10^8 \Omega$	$3.17 \times 10^{10} \Omega$	meet spec.
	Voltage Proof		No breakdown or flashover	No breakdown and flashover			meet spec.
Examination product	3	No visual change	No visual change			meet spec.

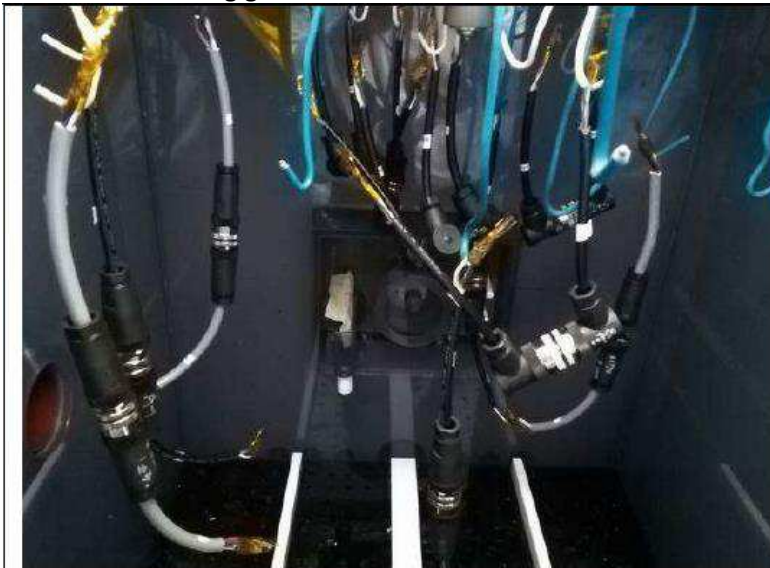
2.4.1 Mixed flowing gas

Gas	Test Condition	
	Source(S)	Test Spec.(Ct)
Cl <sub>2</sub>	100ppm	10ppb
NO <sub>2</sub>	0.10%	200ppb
NO <sub>2</sub>		
H <sub>2</sub> S	99.5ppm	10ppb
H <sub>2</sub> S		
SO <sub>2</sub>	1%	200ppb
SO <sub>2</sub>		
Dry-bulb Temp.	30°C	30°C
Wet-bulb Temp.	70%	25.5°C

Group	Test Item	Sample Number	Requirement	Result			Conclusion
				Max.	Min.	Ave.	
C	Mixed flowing gas	3	No corrosion and defect	Refer to Fig.11			meet spec.
	LLCR	3	$\Delta 15 \text{ m}\Omega$ Max.	4.85	1.41	2.42	meet spec.
	Insulation resistance	3	100M $\Omega$ Min.	$6.24 \times 10^{10} \Omega$	$1.94 \times 10^{10} \Omega$	$3.19 \times 10^{10} \Omega$	meet spec.
	Voltage Proof	3	No breakdown or flashover	No breakdown and flashover			meet spec.
	Impacting water	3	No ingress of water	Refer to Fig.10			meet spec.
	Insulation resistance	3	100M $\Omega$ Min.	2.84	1.17	1.97	meet spec.
	Voltage Proof	3	No breakdown or flashover	No breakdown and flashover			meet spec.
	Examination product	3	No defect	No visual change			meet spec.

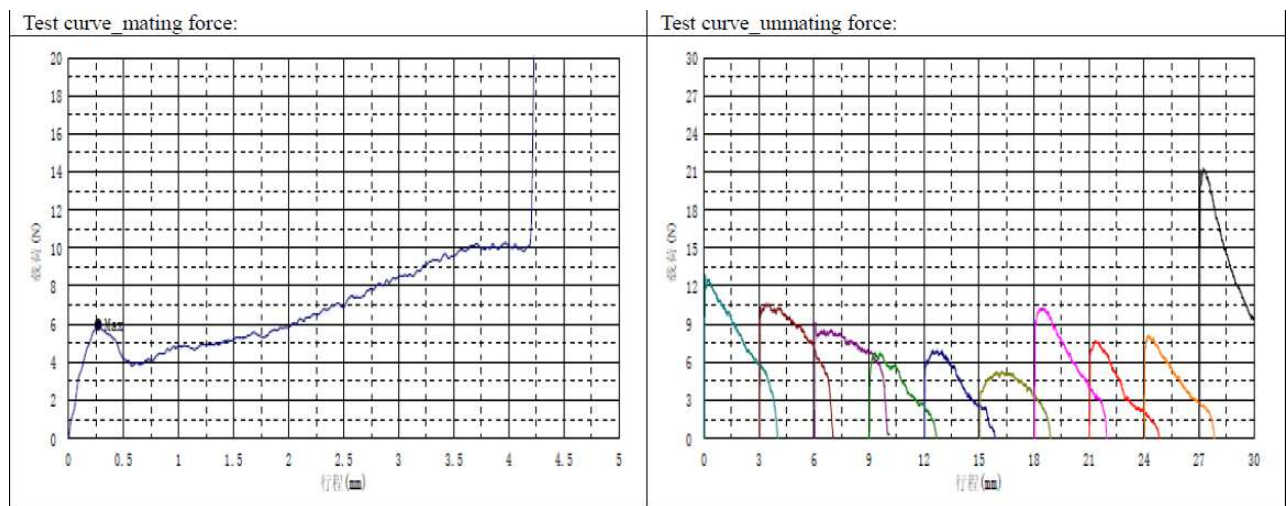
2.6.2 After durability test the mating & unmating force

Group	Test Item	Sample Number	Requirement	Result			Conclusion
				Max.	Min.	Ave.	
E	LLCR	3	$\Delta 15 \text{ m}\Omega$ Max.	6.04	3.83	5.06	meet spec.
	Mating and Unmating Force	3	Refer to 108-106140	Refer to Fig.13			meet spec.
	Durability	3	No physical damage	No physical damage			meet spec.
	Mating and Unmating Force	3	Refer to 108-106140	Refer to Fig.14			meet spec.
	LLCR	3	$\Delta 15 \text{ m}\Omega$ Max.	6.84	2.53	3.56	meet spec.
