SYDNEY PANEL ANTENNA MDVT Report

Project Number: PRJ-22-000902852

Description: SYDNEY PANEL ANTENNA MDVT REPORT

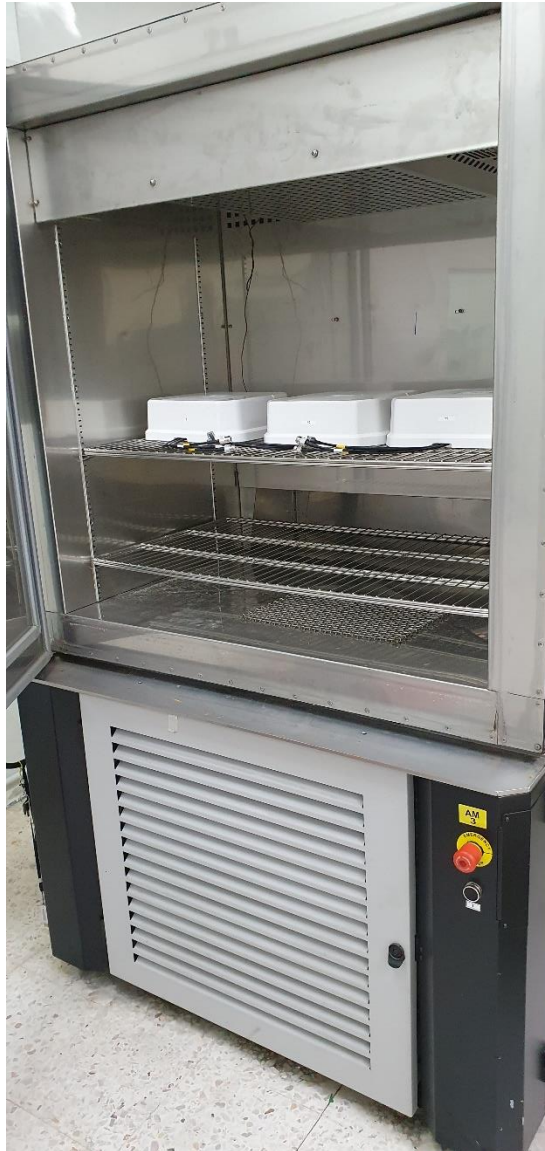
Temperature Cycling Test Setup

- -40°C to 85°C
- 2 hour soak
- 2°/min ramp
- 15 Cycles, ramp up from ambient at beginning of cycle.

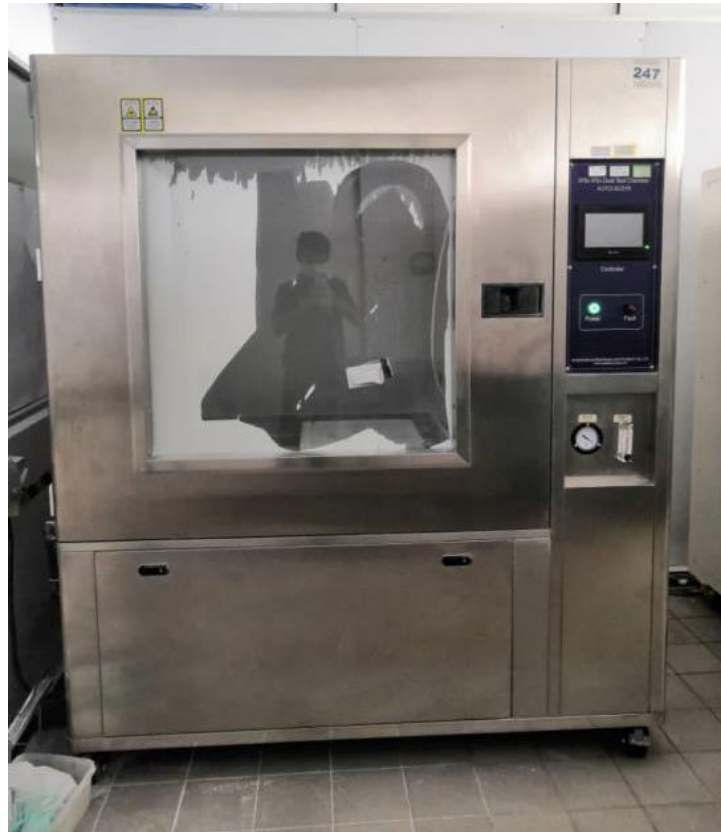
Dust Ingress IP6X Test Setup

Type of Test : Dust Test IP6X
Test Specification : IEC 60529
Category : Category -1
Test Time : 8 hours
Sample Quantity : 3 units

Machine : Dust Tester
Model : AUTO/2019032001
Calibration Due Date : 13th December 2022

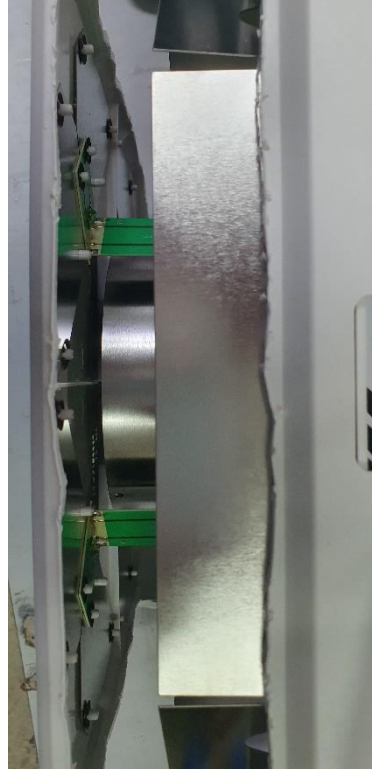
N19

No Ingress of Talc Powder
found in all 3 antenna

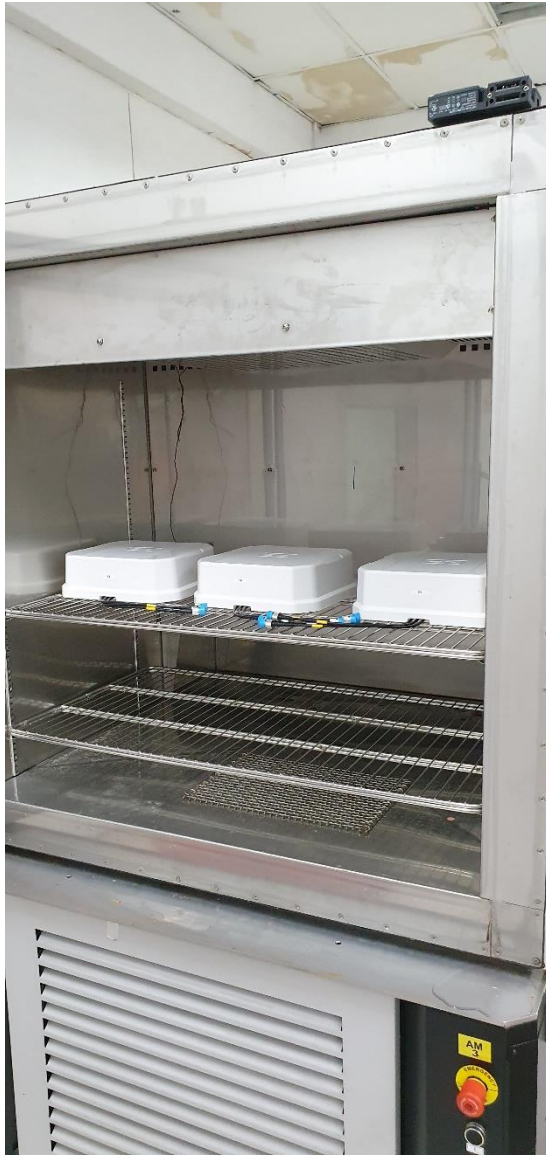
Humidity Test Setup

95%±4% relative humidity, 24 hour cycle, 5 cycles

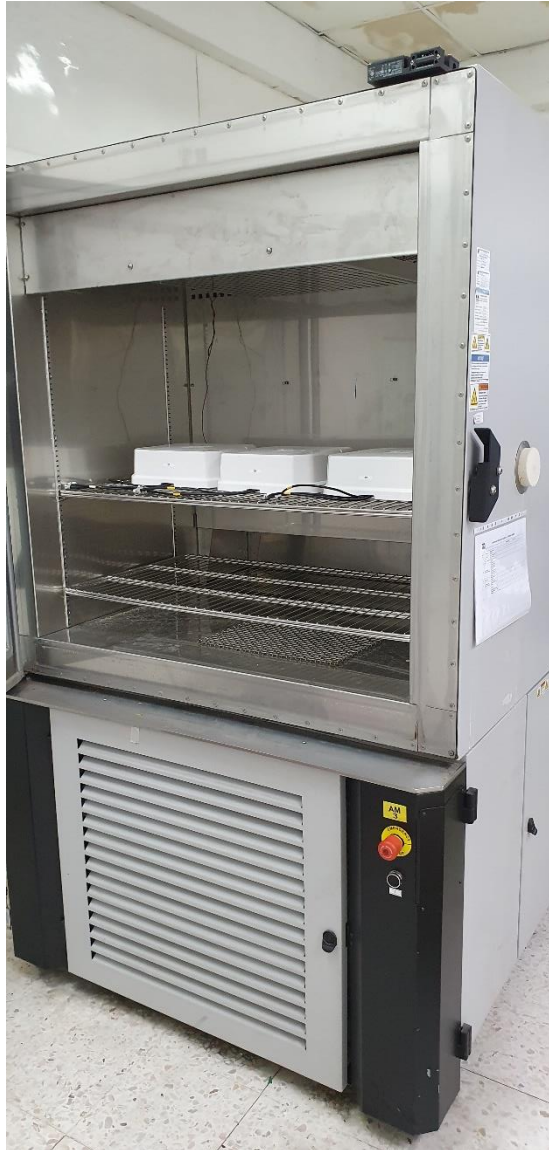
Thermal Shock Test Setup

- -30°C to +70°C
- 1 hour soak
- 5°/min minimum ramp
- 5 Cycles, ramp up from ambient at beginning of cycle.

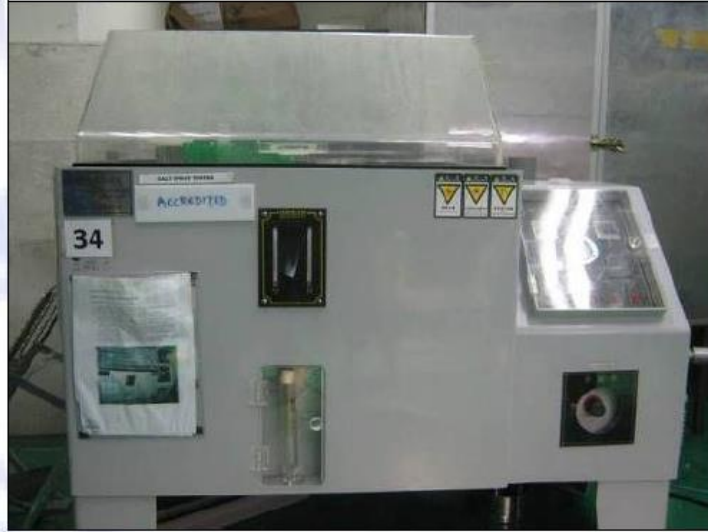
Corrosive Atmosphere Test Setup

Chamber : Welltech Salt Spray Tester
Model : SP-110
Chamber Serial : 0505066

Chamber : Environmental Chamber
Manufacturer : Espec
Serial No : 13006667

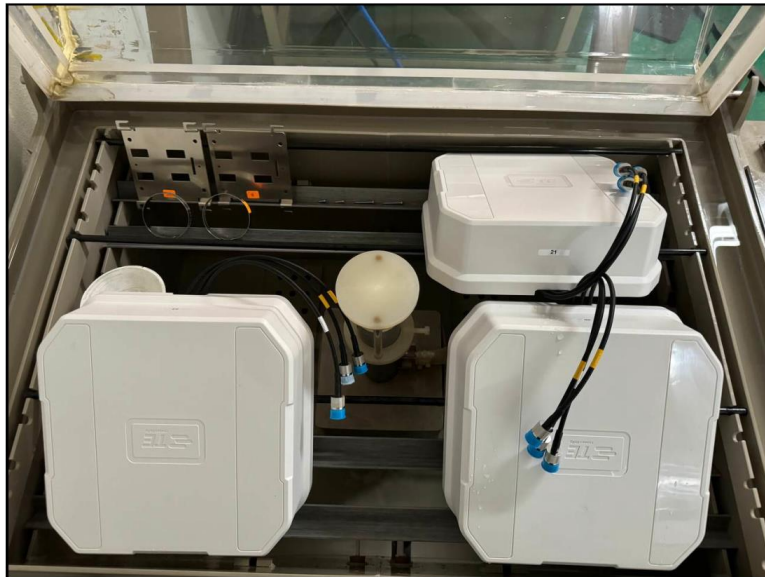
Corrosive Atmosphere Test Setup

Test Spec	: MIL-STD-810G, Method 509.5
NaCl Concentration	: 5%± 1%
Pressured Tank Temperature	: 46°C - 49°C
Cabinet Temperature	: 33.3°C - 36.1°C
PH Level	: 6.5-7.2
Test Cycle	: 24hr wet/24hr dry: total 2 cycles

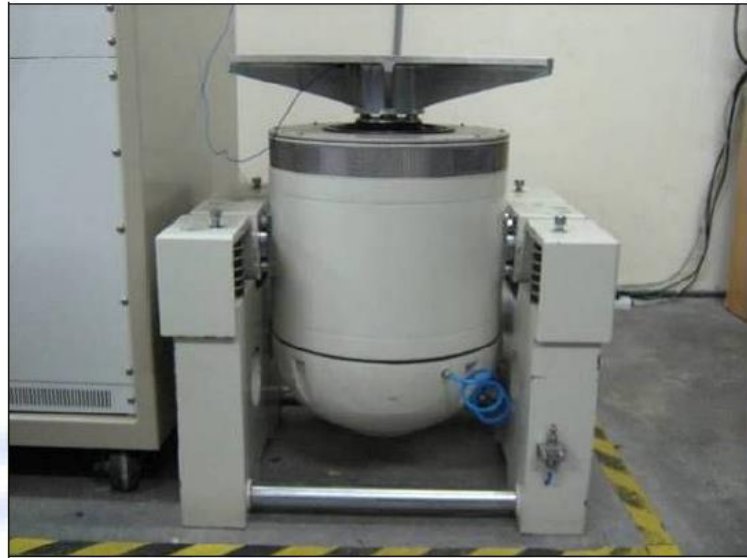
Vibration, Random Test Setup

Test : Random Vibration Test
 Specification : IEC 60068-2-64, Stationary Installation, Category 3
 G Level : 7 Grms
 Time Duration/Axis : 1 hour/Axis
 Axis : 3 axis (Vertical, Transverse, Longitudinal)
 Total Loading : 1 Loading

Equipment : STI Vibration Tester
 Equipment Serial # : D-150-2

Accelerometers
 Equipment : Charge Accelerometer
 Model Number : 357B03
 Equipment Serial # : LW56135
Sensitivity@100.0Hz: 9.98 pC/g

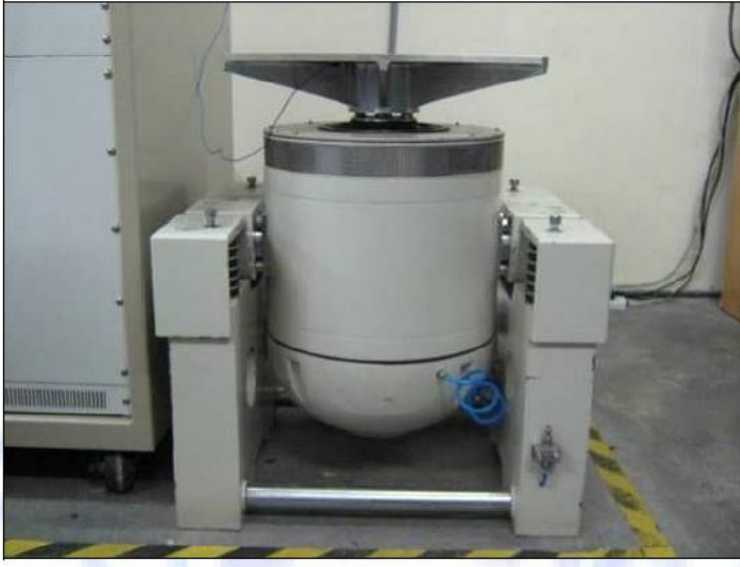
Mechanical Shock Test Setup

Equipment : STI Vibration Tester
Equipment Serial # : D-150-2

Equipment : Charge Accelerometer
Model Number : 357B03
Equipment Serial # : LW56135
[Sensitivity@ 100.0Hz](#): 9.98 pC/g

Test : Mechanical Shock
Specification : IEC60068-2-27
G Level : 30G
Pulse Width : 18ms
Shock Type : Half-sine
Axis : 6 axis (+x,+y,+z,-x,-y,-z)
Shock/Axis : 3 shocks/axis
Total Loading : 1 Loading

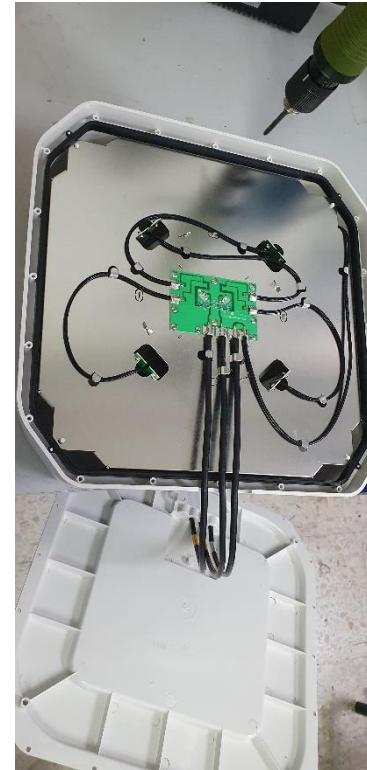
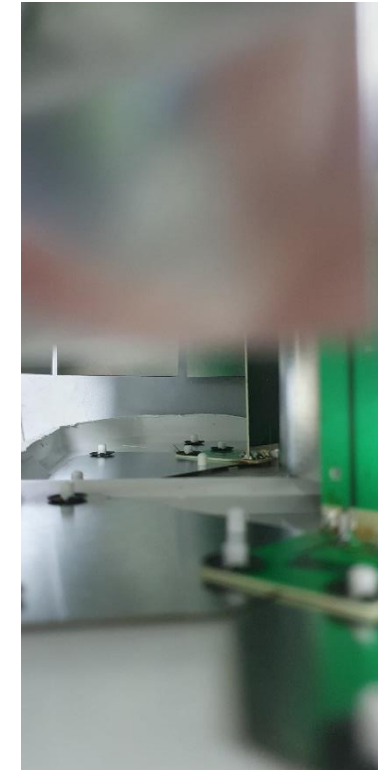
No physical damage was observed after test.

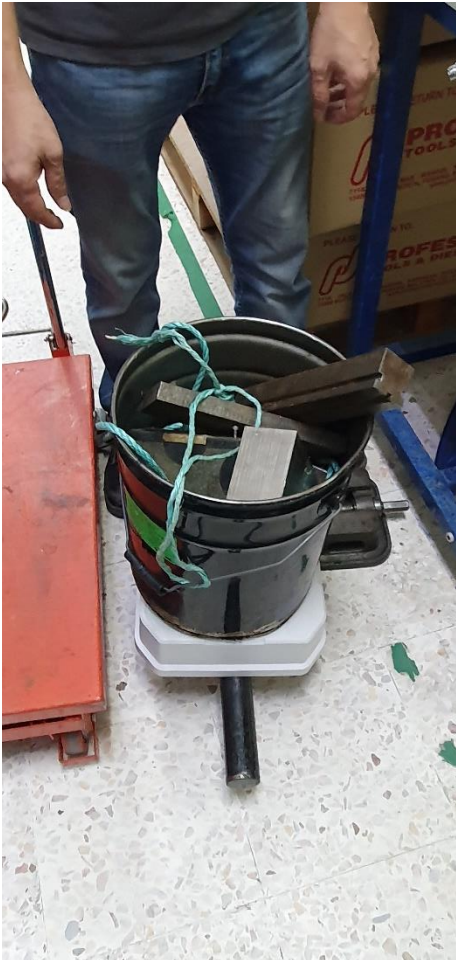
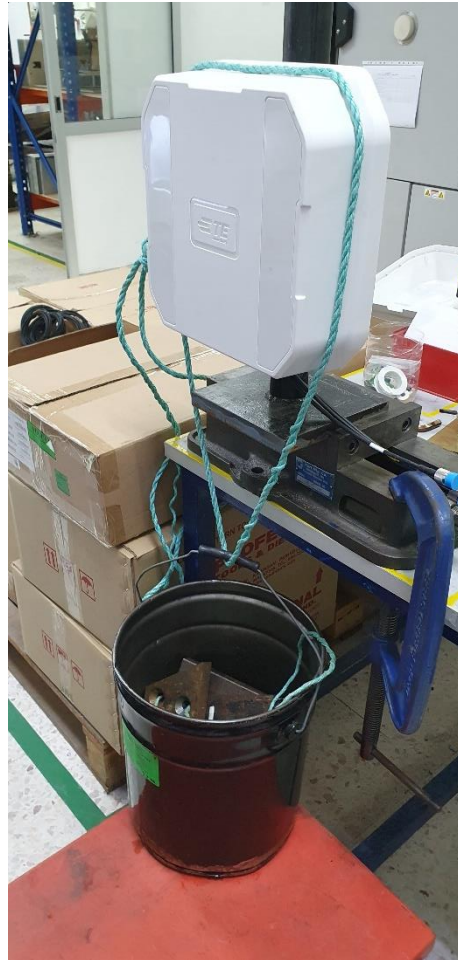
Wind Survival Test Setup

Duration: 15 seconds

- 49.55 Kg on front surface
- 19.47 Kg on side surfaces

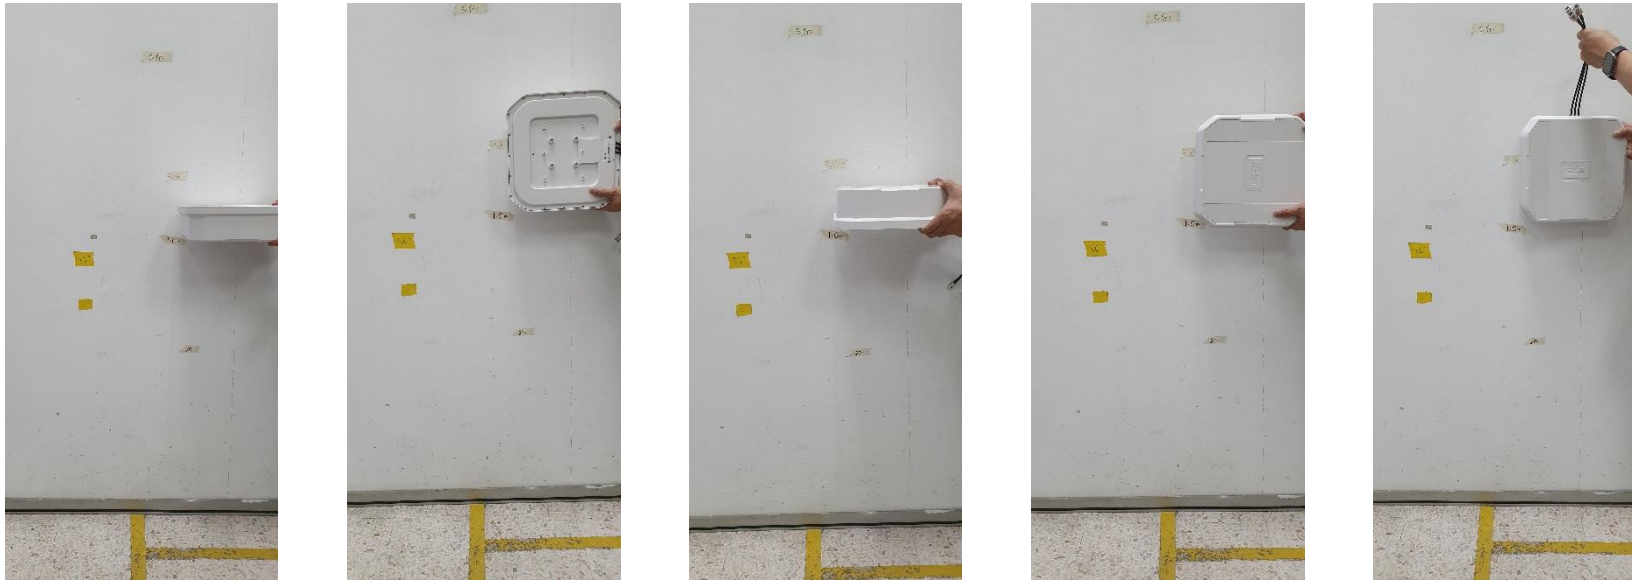
Unpackaged Drop Test Setup

Drop from a height of 1 Meter

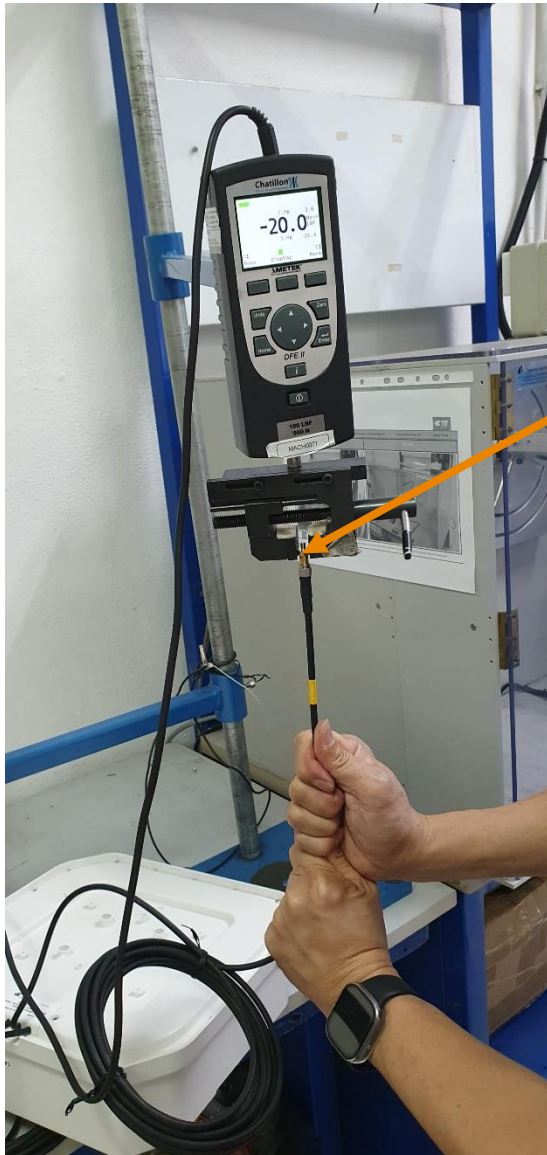
Cable Pull Test Setup

Mate with dummy
connector

Duration: 30 seconds
Pull force: 20 lbs

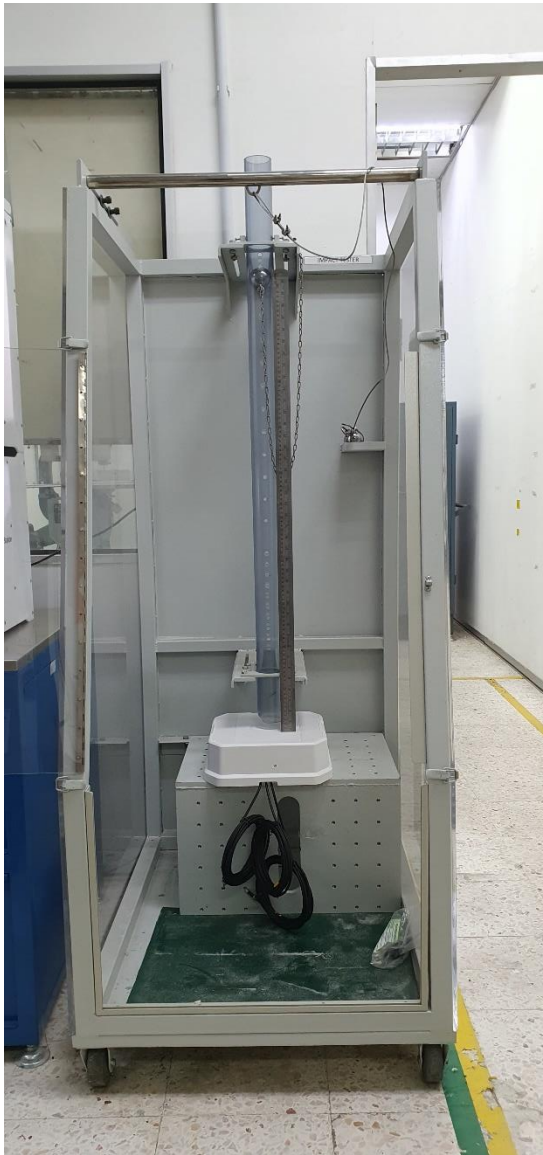
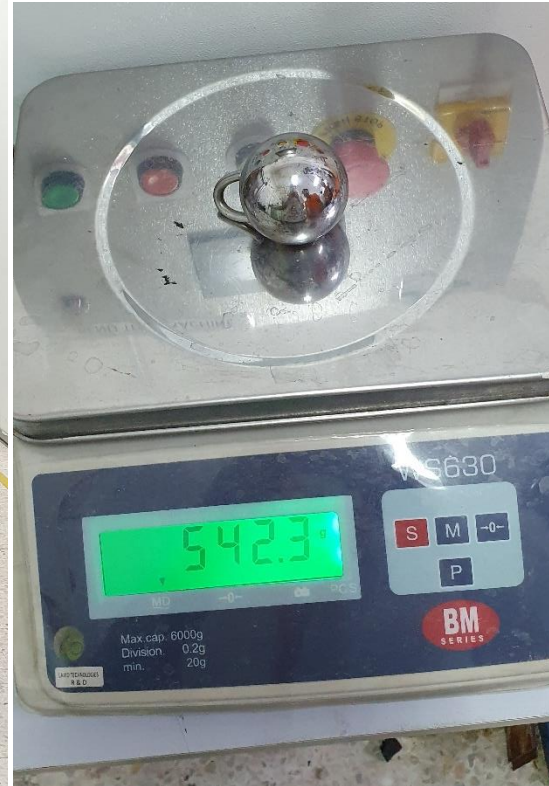
Impact Test Setup

Mass Steel Ball: 542g
Height: 1m

Impact energy: $0.542 \times 9.81 \times 1 = 5.3$ Joule
