**Ingress Protection Evaluation of CPC Plugs**

Testing was performed on the TE Connectivity (TE) Circular Plastic Connector (CPC) plugs in combination with 10 and 7.5 mm cable, cable entry boots and heat shrink tubing to determine their conformance to IEC60529 tests IPX5 and IP6X.

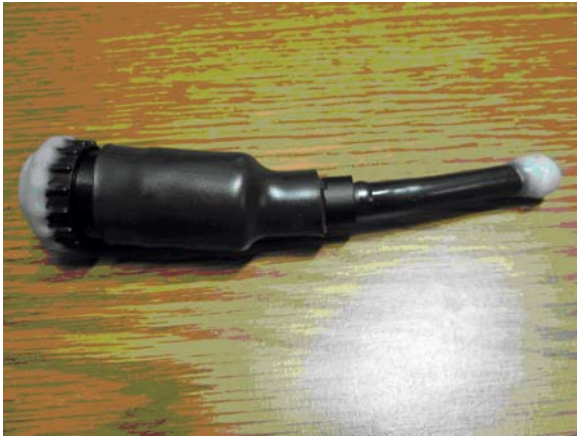
Figure 1

Specimens identified with the following part numbers were used for test. See Figures 1, 2 and 3.

Test Group	Quantity	Part Number	Description
1,3	5 each	206037-2	CPC plug, Size 17
		213933-1	Cable entry seal boot
		HTAT-32/8	Heat shrink tubing
		NA	Customer supplied 7.5 mm cable
2	4	206037-2	CPC plug, Size 17
		213933-1	Cable entry seal boot
		ATUM-40/13	Heat shrink tubing
		NA	Customer supplied 10 mm cable
4	5	206037-2	CPC plug, Size 17
		213933-1	Cable entry seal boot
		ATUM-40/13	Heat shrink tubing
		NA	Customer supplied 10 mm cable
